CENTRAL INTELLIGENCE AGENCY

SUBJECT Plovdiv Airfield : DATE DISTR. 3 September 1958

PLOVDIV AIRFIELD

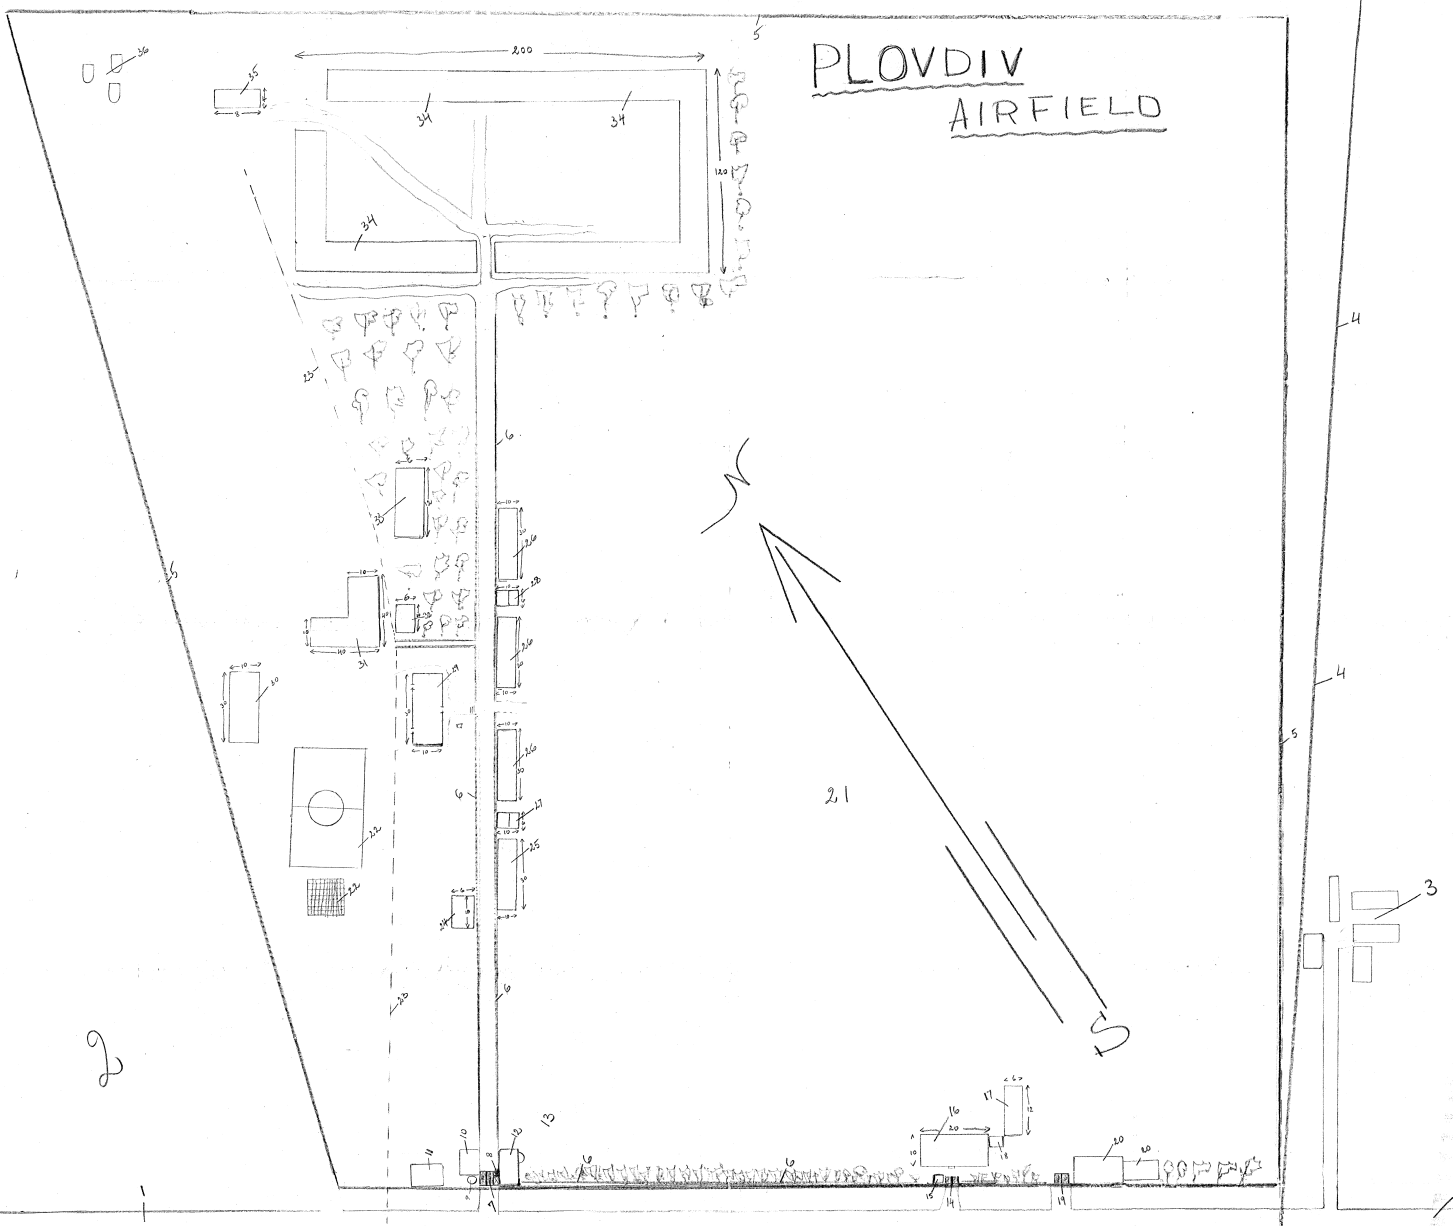
[redacted] as an attachment to this report is a sketch of Plovdiv airfield with an attached legend.

LEGEND TO SKETCH OF PLOVDIV AIRFIELD
